## Inspection Report

## ***PROPERTY INSPECTION REPORT***

**Concerning:** 1234 Big Tree, Houston, TX 77056  
(Address of Inspected Property)

**By:** Alvaro Nieto, 20719 06/26/2020  
(Name and License Number of Inspector) (Date)

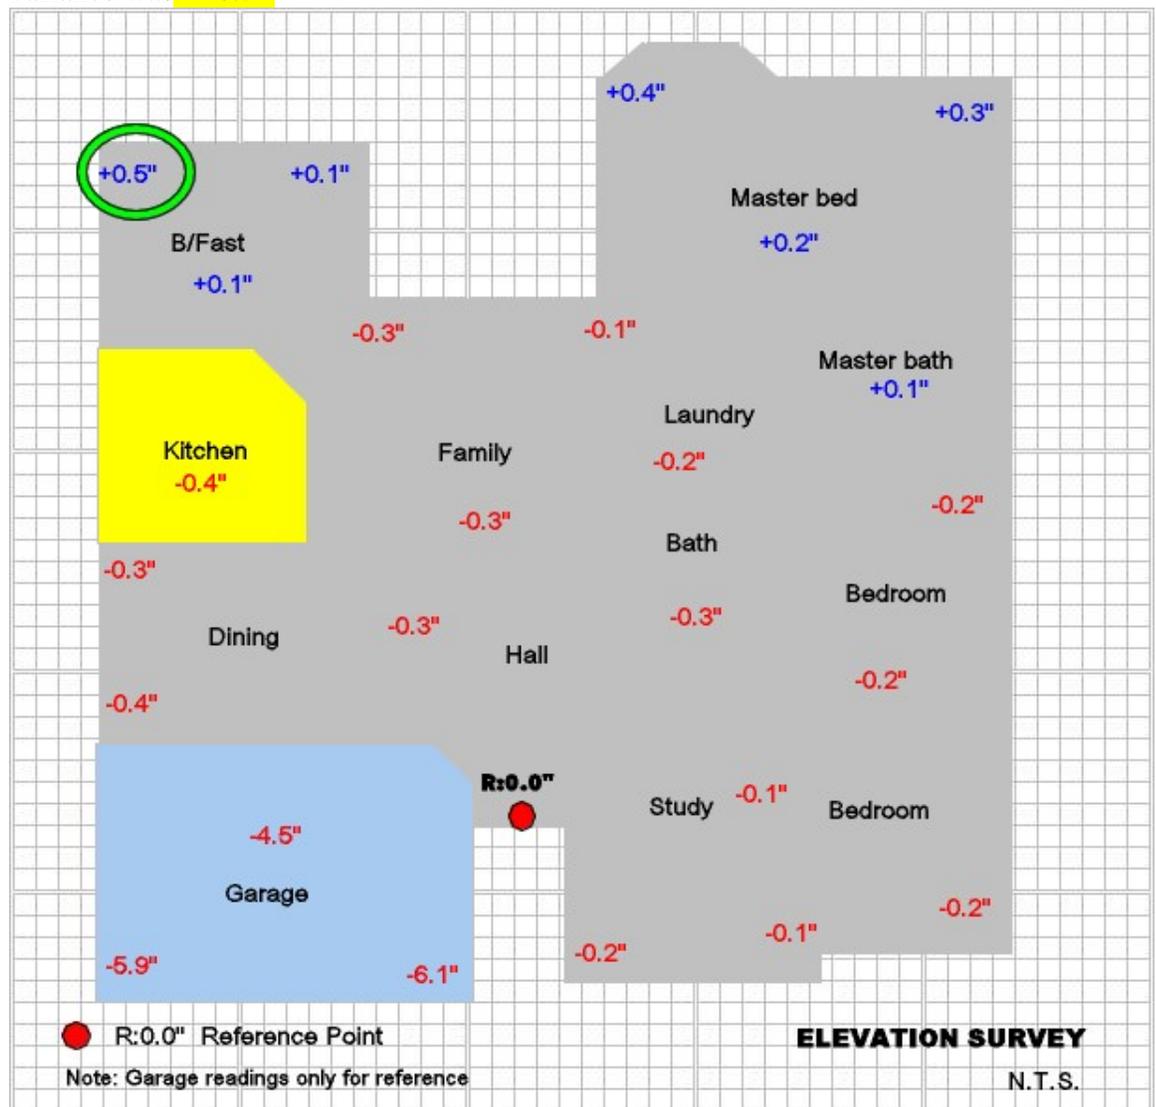
A foundation elevation survey was conducted during the inspection. The floorplan below represents data gathered using a Zip Level or similar instrument and adjusting for floor covering height differences. i.e. differences between tile, carpet and wood flooring(except step down to garage). Measurements are listed to the nearest 1/10th of an inch. Greatest variance was: **+ 0.5"**

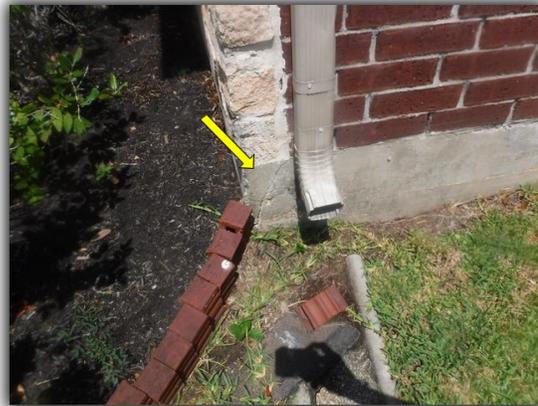
*Spalling (i.e., corner pops) at one or more corner(s), Corner spalling is common to slab foundations and does not affect the structural integrity of the foundation.*

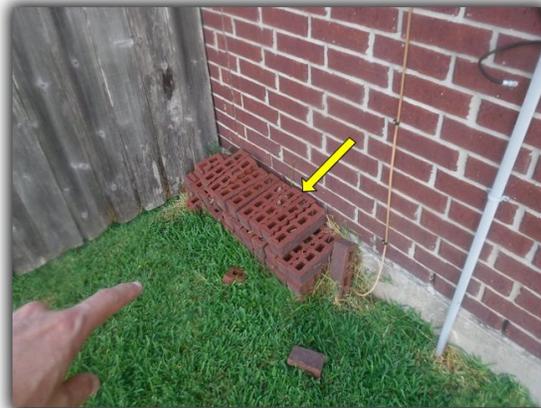
Bricks, stone, etc. should not be stored near the house or garage, can hide evidence of wood-destroying insect activity, recommend relocating away from house/garage.

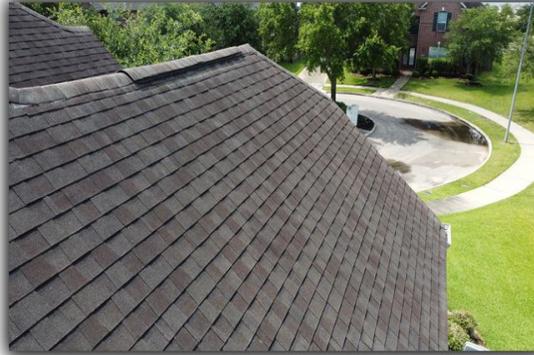
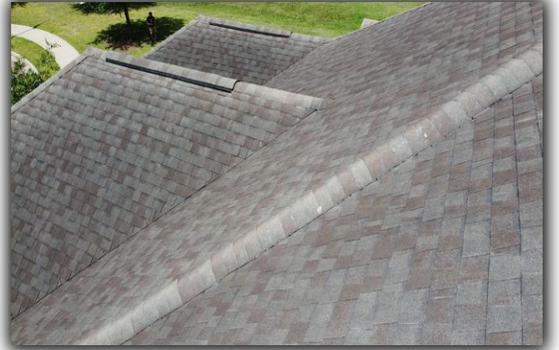
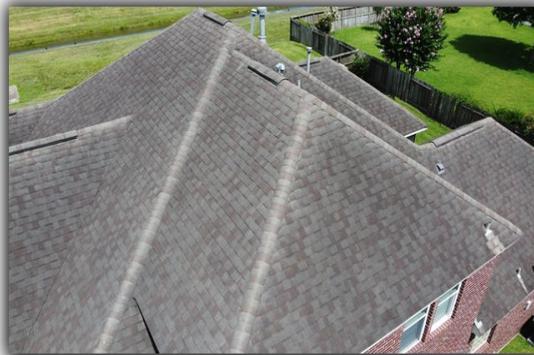
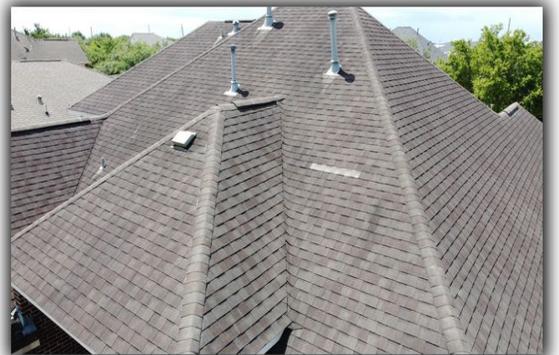
Older roof, nearing the end (**last 1/3 to 1/4**) of serviceable life. Observed Brittle, cracked, curled ends, and/or excessive granular loss of shingles.

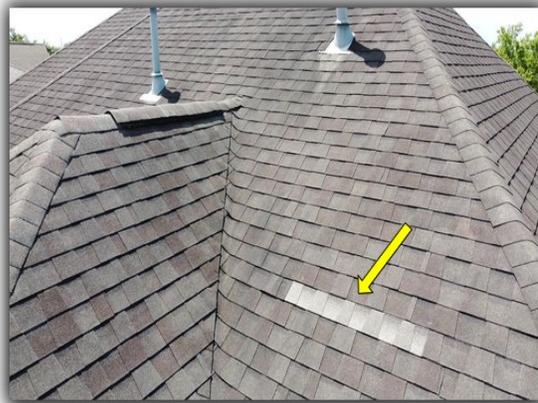
Observed spot repairs to the roof surface.

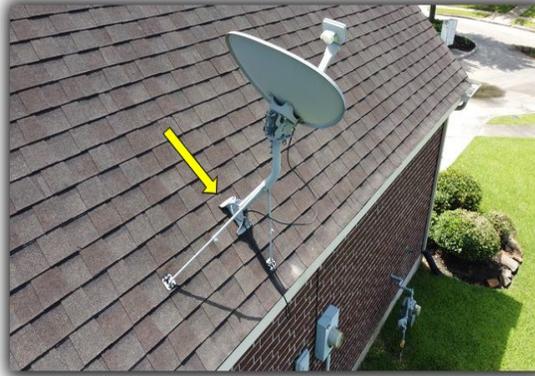
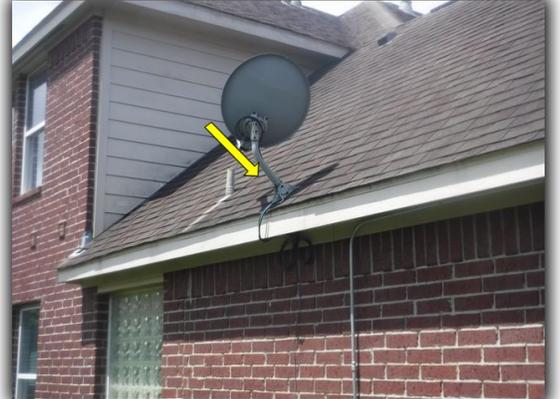
*Observed satellite dishes/antenna on roof - historically satellite dishes have caused damage to roofs due to improper installation techniques. Recommend removal of dishes and sealing all holes caused by the installation, When/if satellite service is discontinued.*

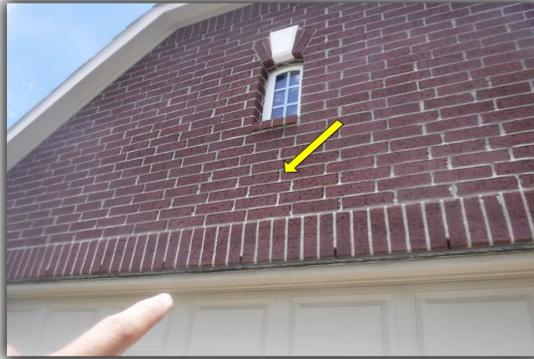
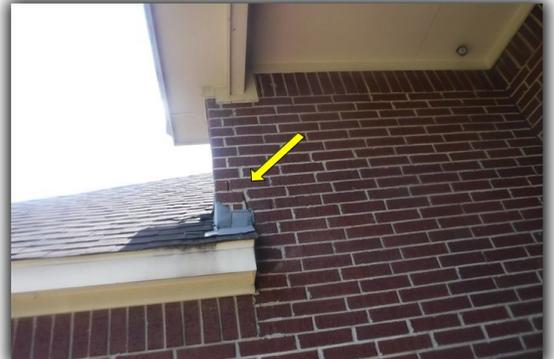
Minor cracks in brick veneer , one or more locations, Recommend buyer take photographs of cracks, their location, and width [ruler across the crack] with a high-resolution camera that has a date stamp for future reference.

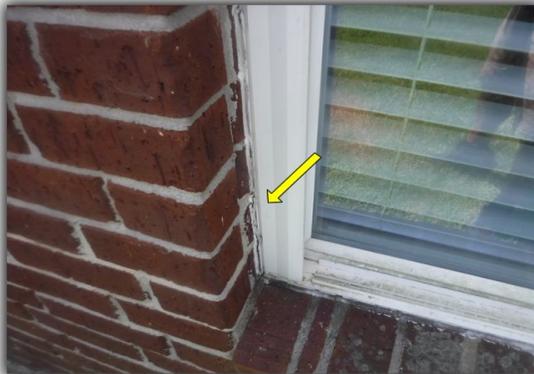
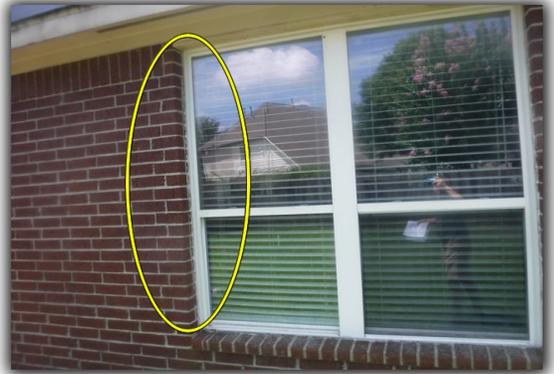
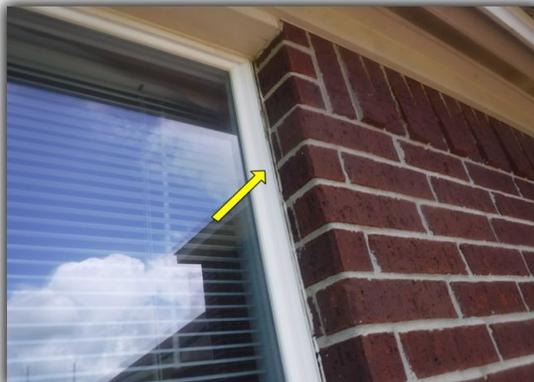
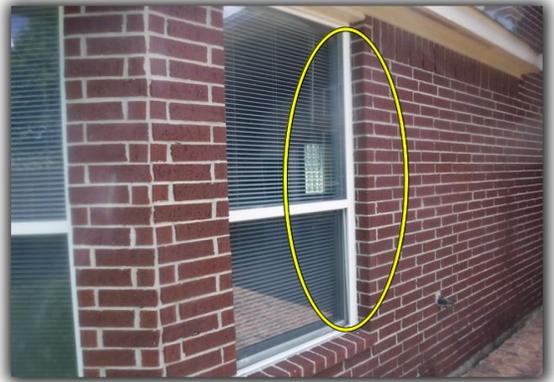
Caulking deficient around one or more windows will allow water penetration during heavy/wind-driven rains.

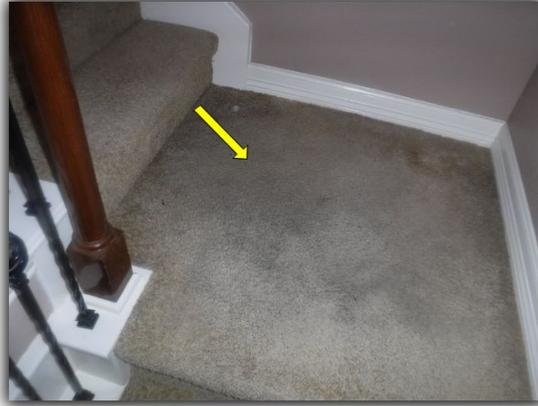
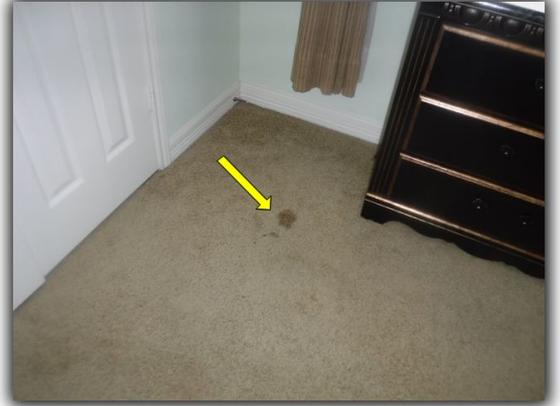
Observed one or more carpet stains in the house.

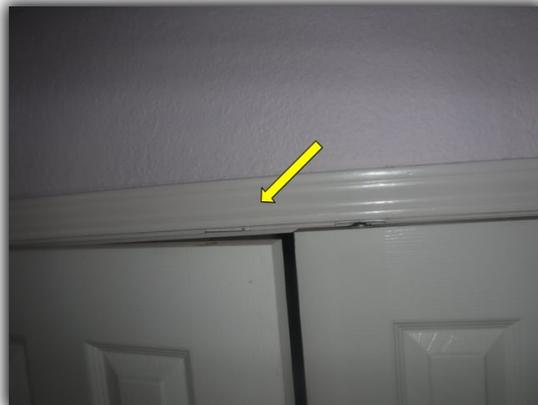
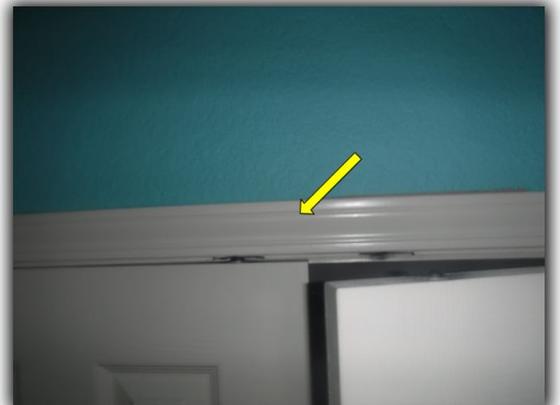
Several latching balls on top of closet doors observed to be defective;

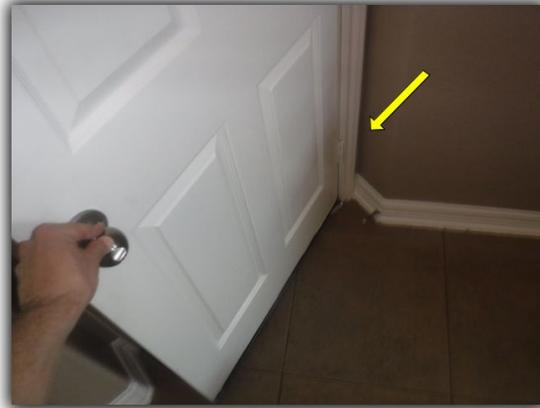
The door between house and garage does not have an operational auto/self-closing device as required by code, reference UBC 302.4 ex.3

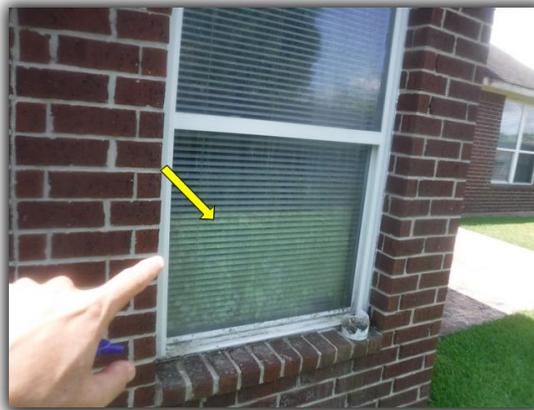
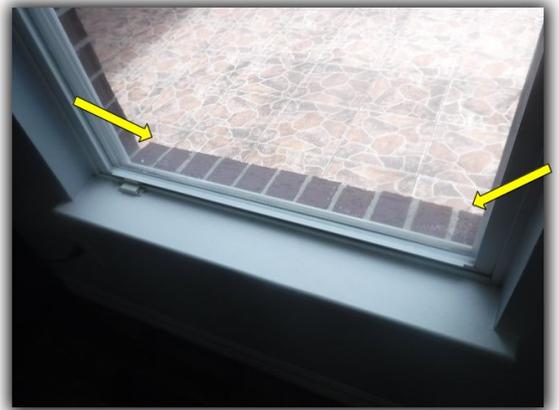
One or more screens are missing and/or damaged.

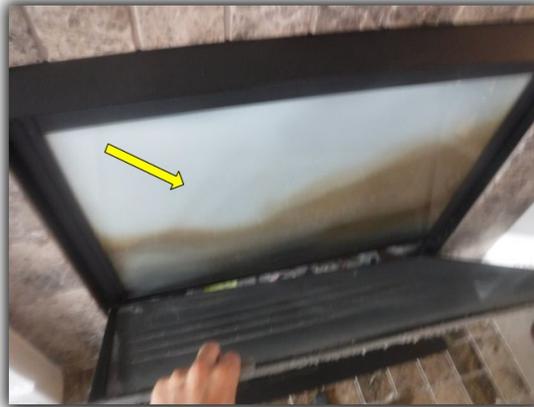
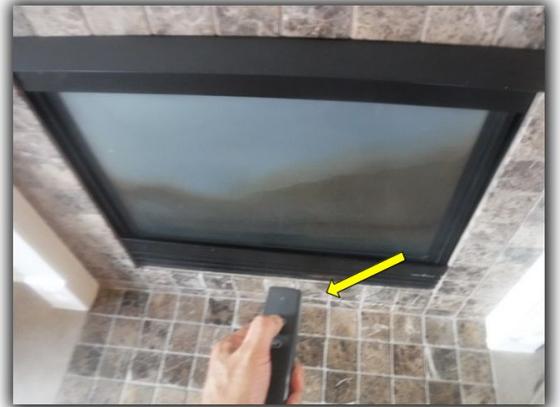
Observed damaged sealed fireplace. Unit was inoperable at time of inspection.

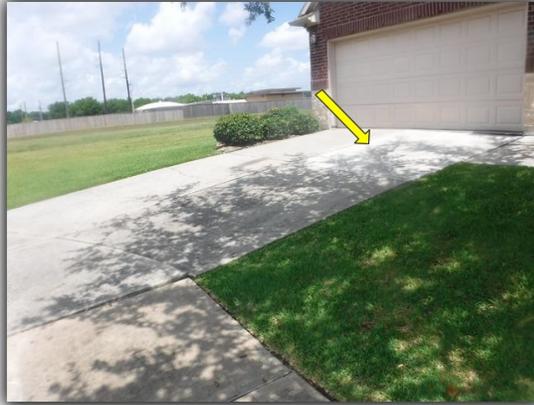
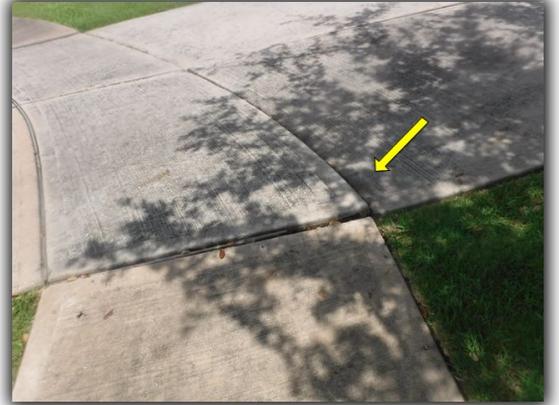
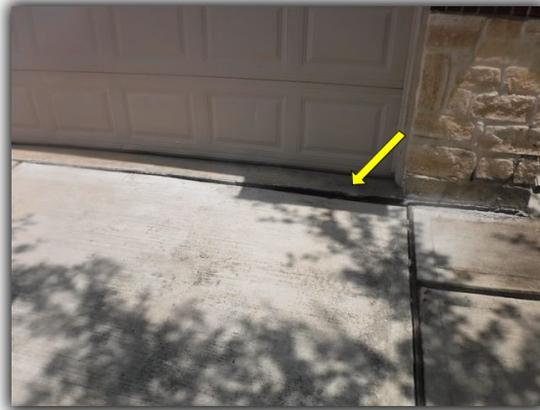
Tripping Hazard(s), walks and driveways are uneven.

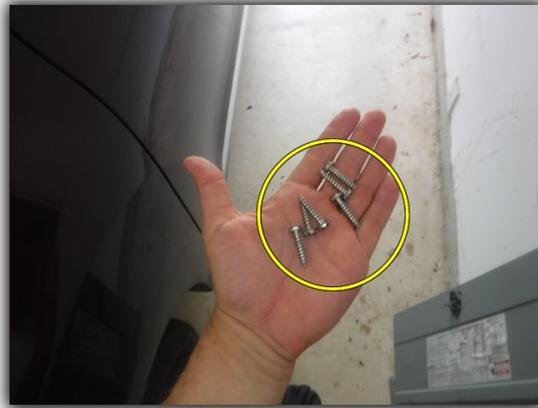
The dead-front is not secured with proper screws with blunted ends, Sharp ends can pierce electrical wire insulation.

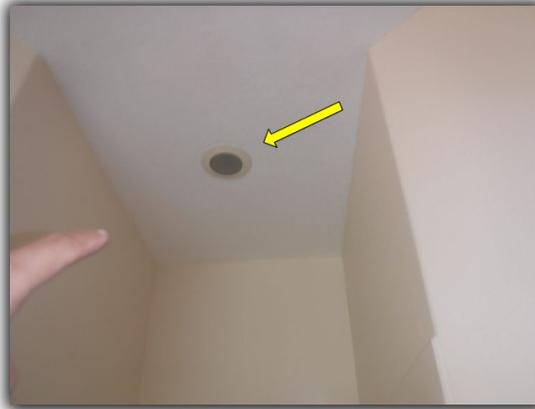
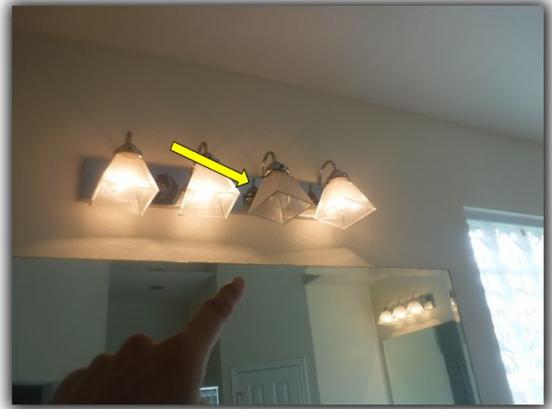
Light(s) found to be not functioning. Probably just a burned-out bulb, or it could be a broken fixture/switch or improper wiring. Including but not limited to: Master bathroom.

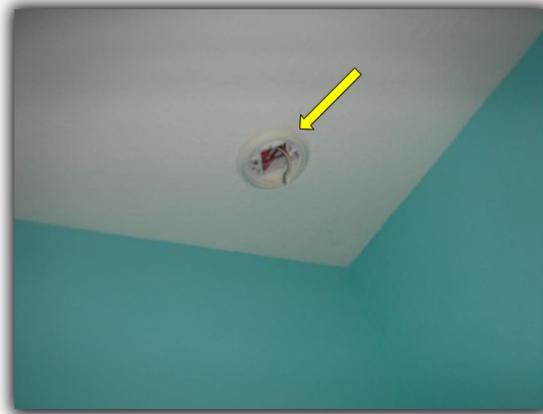
**Observed missing smoke detector on front bedroom at the 1st floor.**

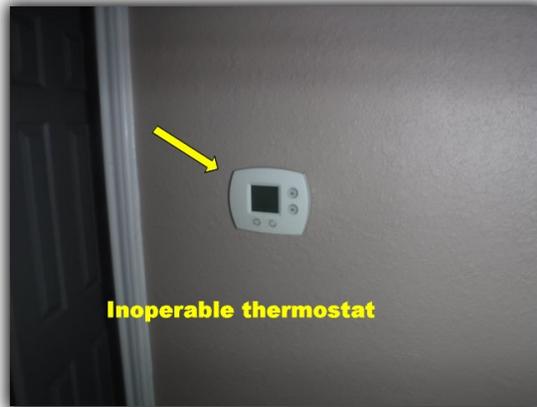
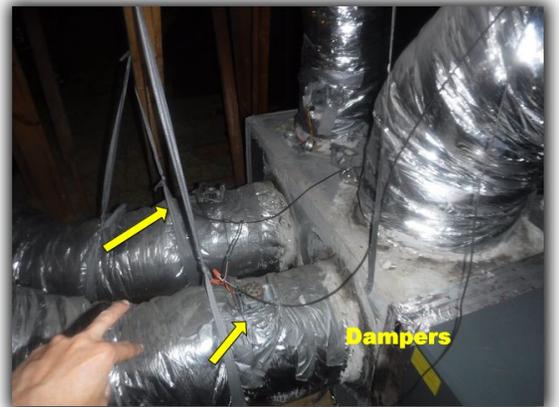
Observed inoperable / disconnected thermostat at the 2nd floor area. Also dampers were observed in attic. Inspector could not verify if a zoning system was previously installed. Recommend further evaluation by a qualified AC contractor.

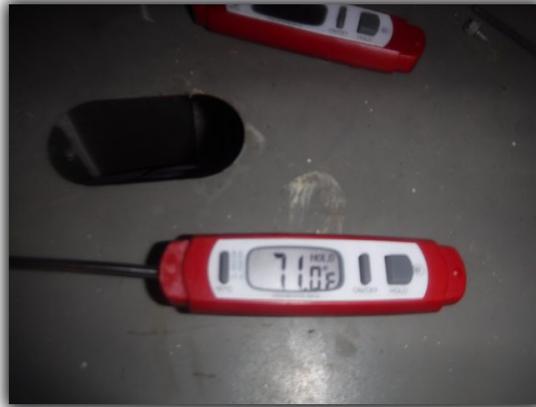
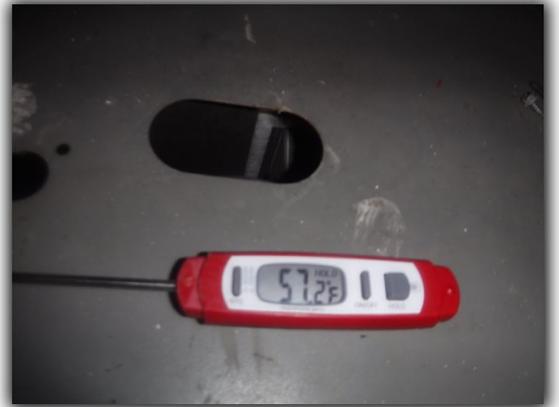
**Recommend qualified/licensed HVAC technician service/repair/replace as needed. Not cooling well.**

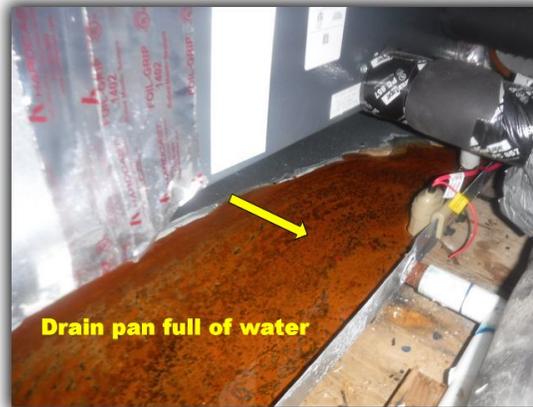
**E-coil is leaking/dripping water. Have serviced to correct cause.**

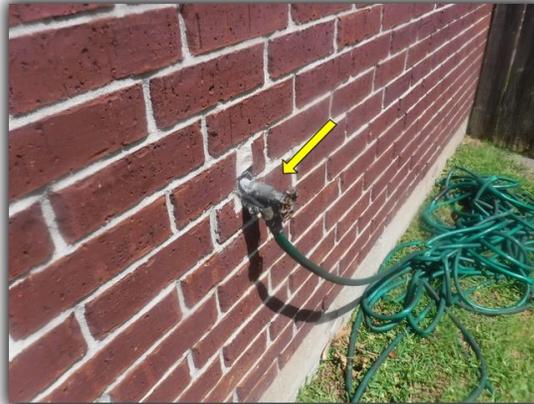
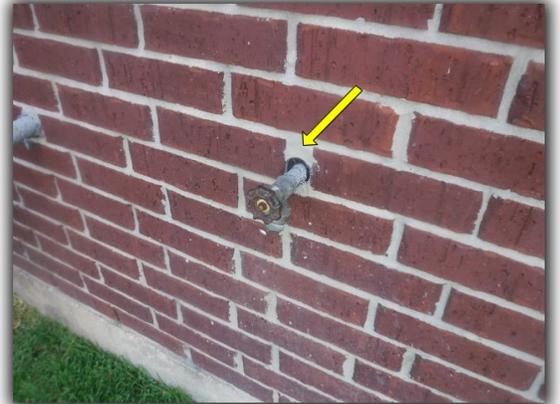
Recommend insulating exterior water line(s) to prevent freeze damage.

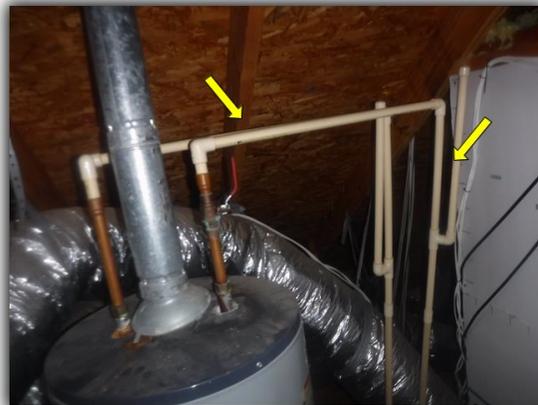
Recommend insulation of exposed water lines in the attic.

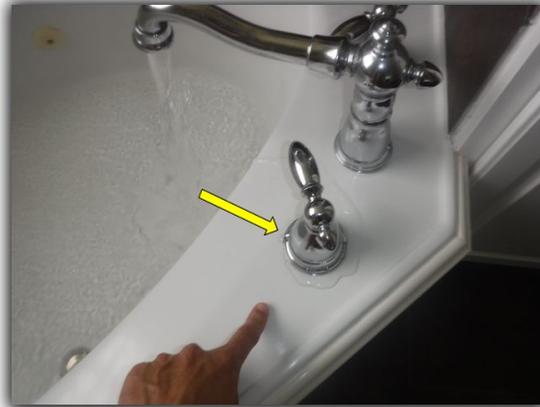
Observed water leak on cold supply faucet on master bathroom tub.

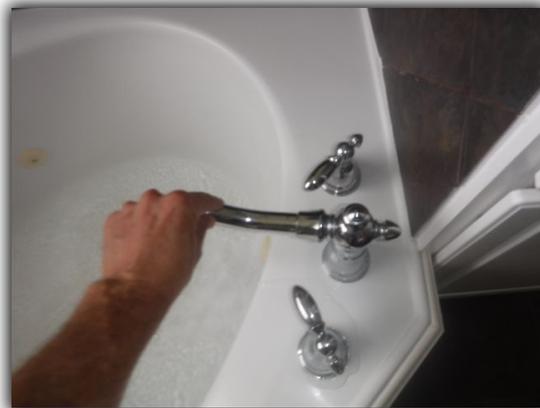
Observed loose faucet on master bathroom tub.

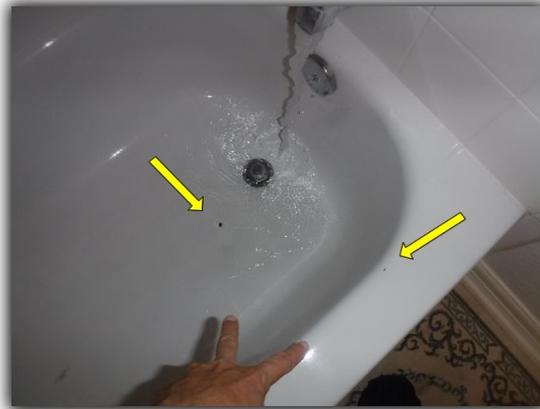
Porcelain damaged/chipped on steel tub: 2nd floor bath.

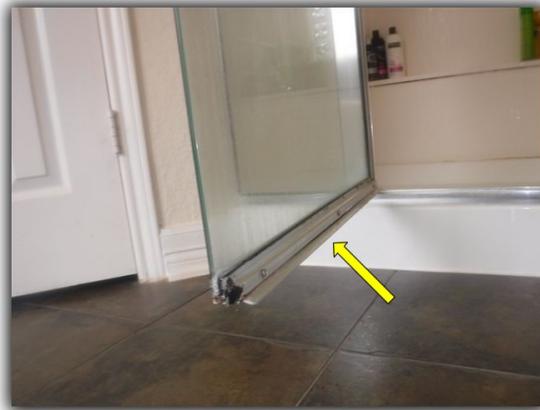
Shower door lower weather stripping loose and/or damaged results in possible water leaking from base of the door, needs repair/replacement: Master bathroom.

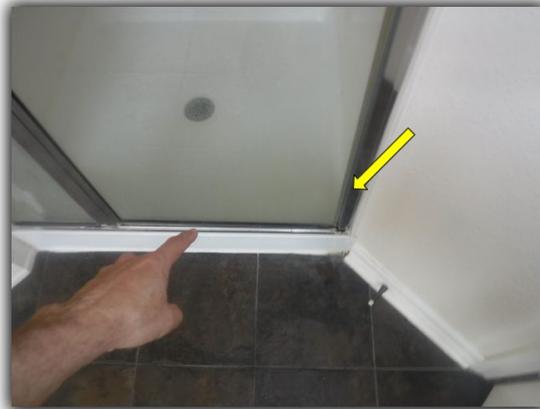
Observed that master bathroom shower door does not close properly.

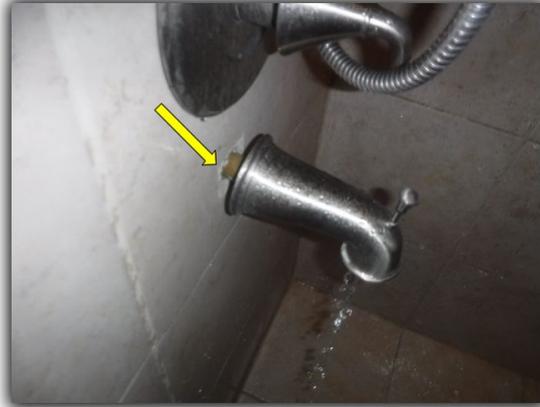
The shower diverter valve at the 1st floor hallway bathroom is not properly installed.

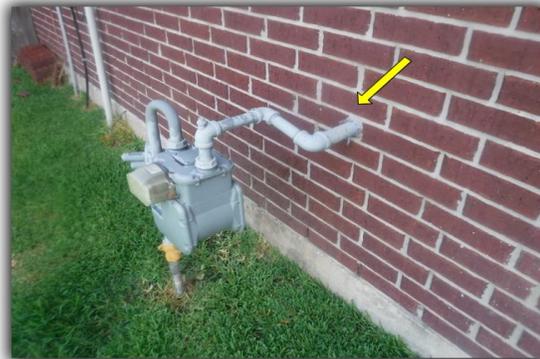
Ground rod/wire missing or damaged at the gas meter.

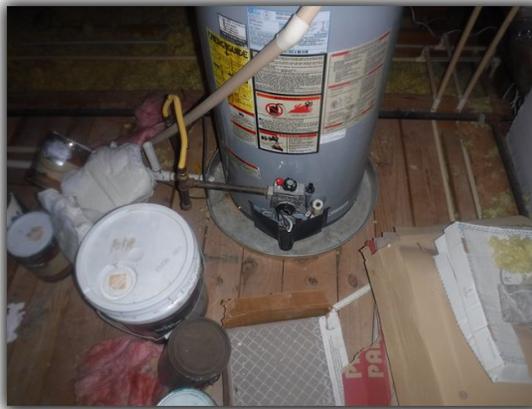
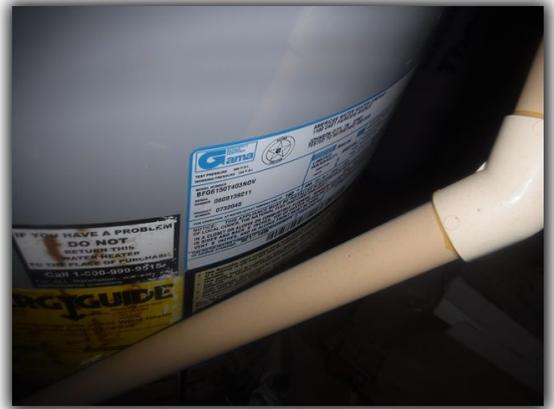
Manufactured in: 2006

**The unit has exceeded its normal serviceable life; budget for repair or replacement.**

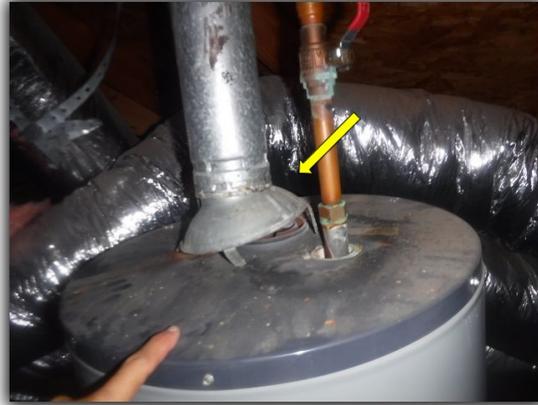
Improperly vented, vent pipe not properly aligned at the top of water heater allowing products of combustion (bad gas) to vent into house/attic.

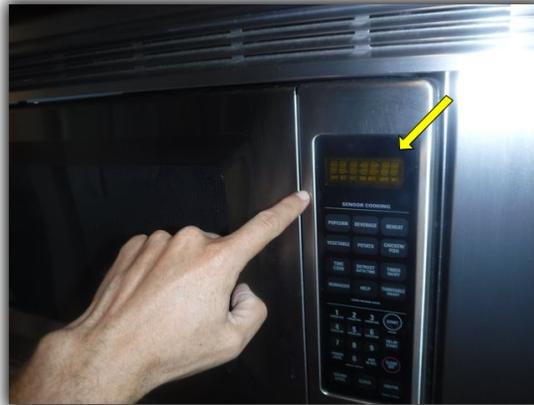
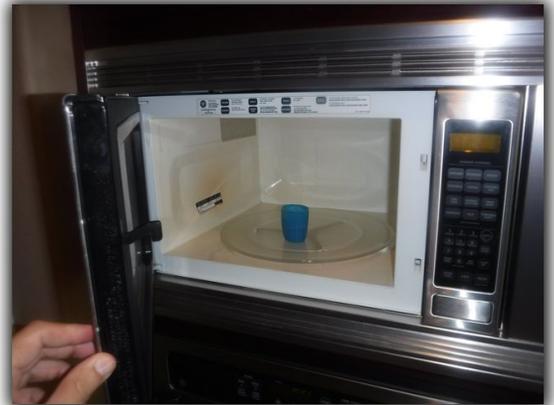
Electronic panel on built in unit is damaged /inoperable.

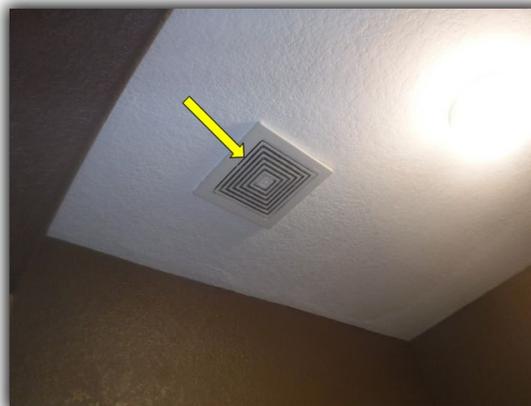
One or more exhaust vent grills have a build-up of dust, recommend cleaning.

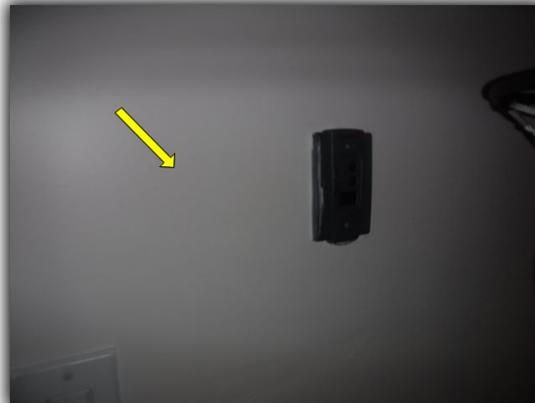
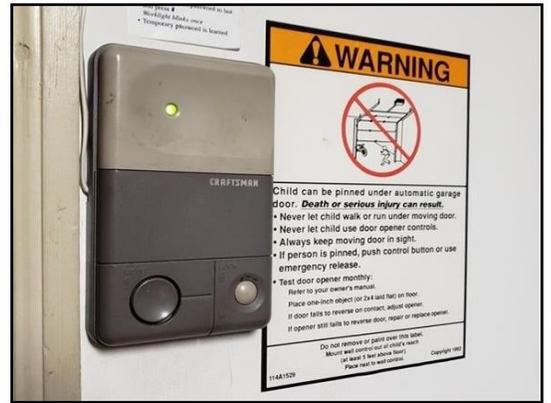
Missing required safety sticker/decal next to the operator button.

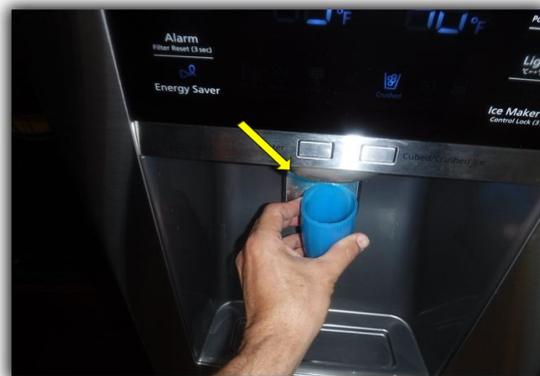
The ice maker was not operational, not performing its intended function, in need of repair/replacement.
