## Inspection Report

## ***PROPERTY INSPECTION REPORT***

**Concerning:** 1234 Big Tree, Houston, TX 77056  
(Address of Inspected Property)

**By:** Alvaro Nieto, 20719 06/26/2020  
(Name and License Number of Inspector) (Date)

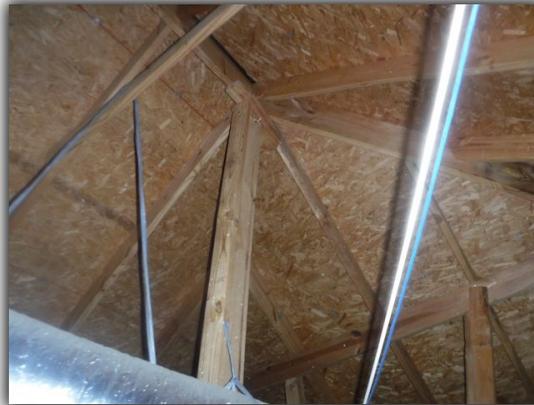
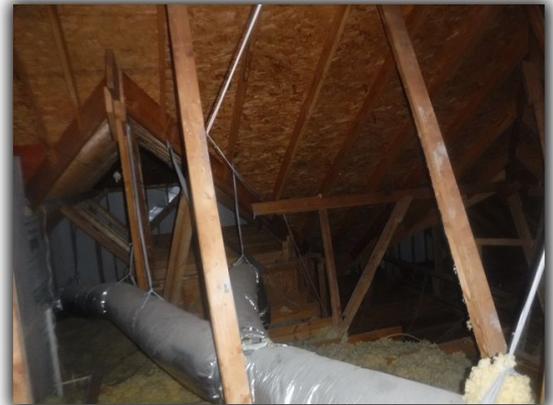
No significant deficiencies or anomalies observed at the time of inspection.

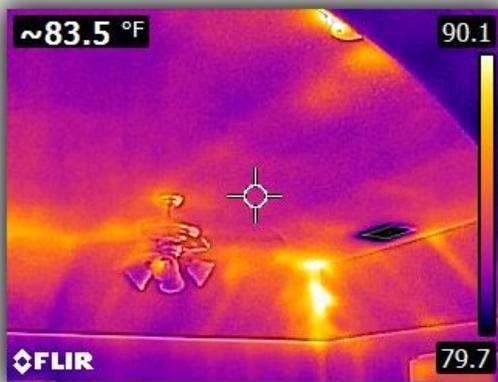
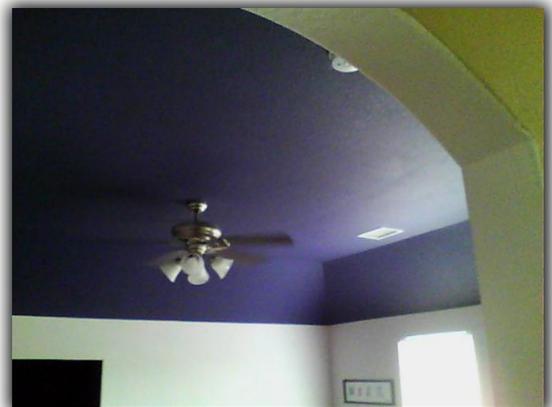
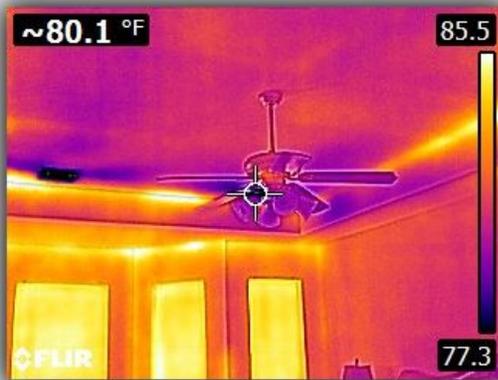
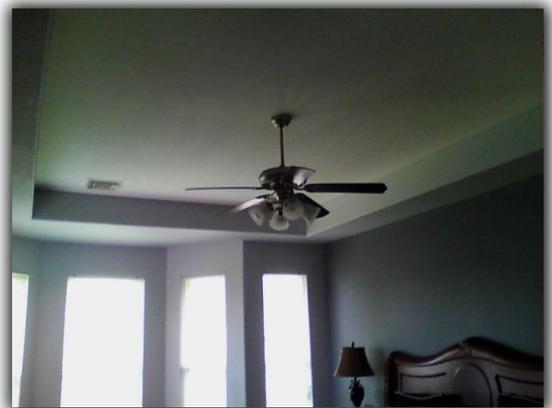
**THERMAL IMAGING:**

No significant deficiencies or anomalies observed at the time of inspection.

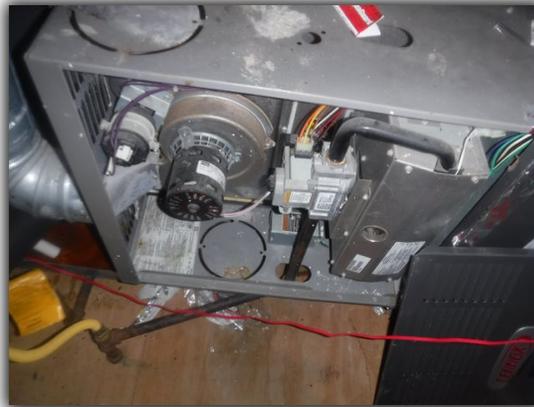
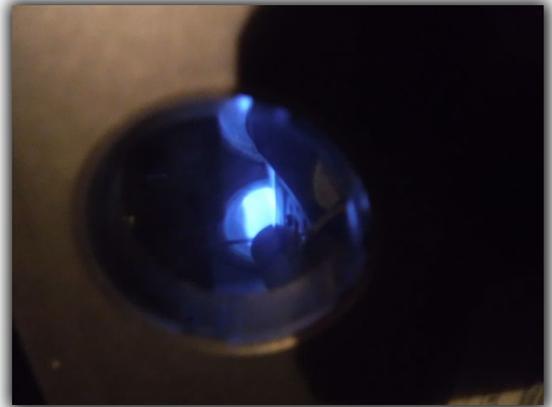
No significant deficiencies or anomalies observed at the time of inspection.

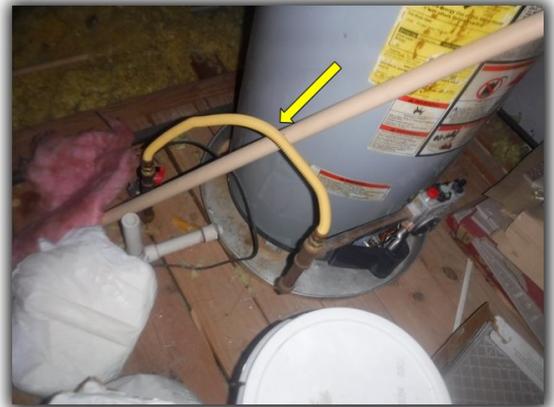
No significant deficiencies or anomalies observed at the time of inspection.

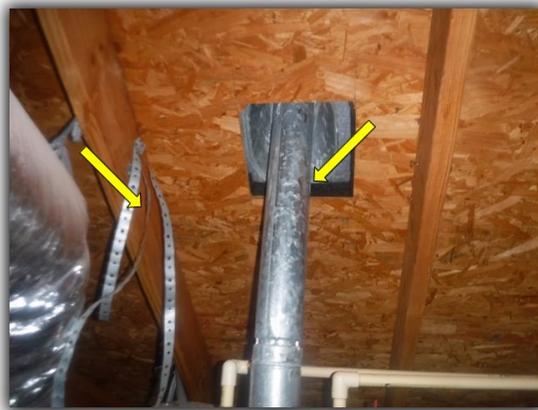
**WATER HEATER EXHAUST VENT(S):**

Vent pipe(s) is (are) not properly secured (strapped) in place.

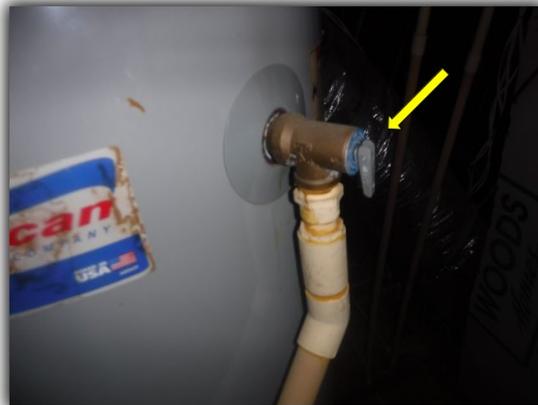
**TEMPERATURE AND PRESSURE RELIEF VALVE(S):**

No significant deficiencies or anomalies observed at the time of inspection.

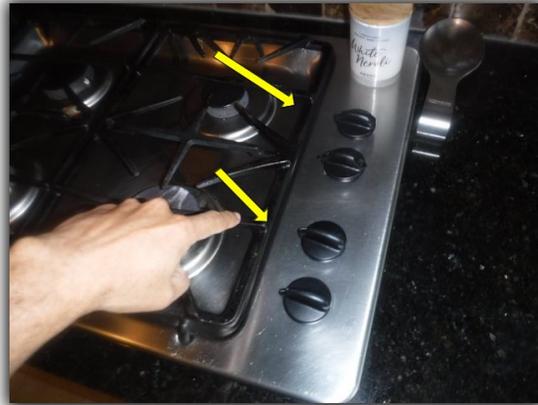
**GAS RANGE/COOKTOP:**

Control knob(s) markings are not legible.

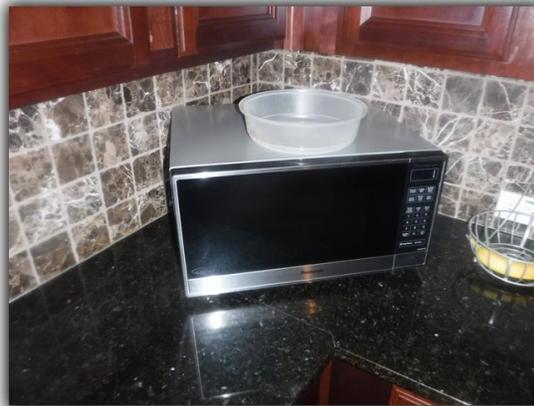
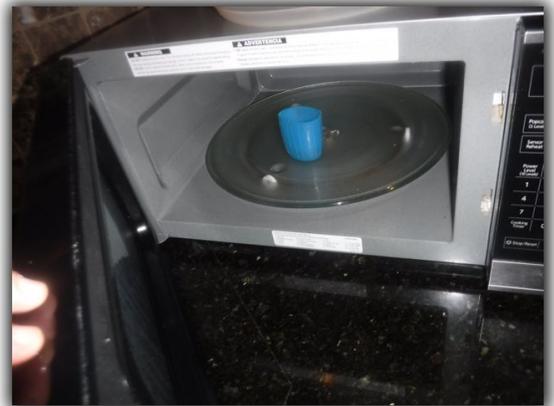
Observed 2nd unit ( not built in) on kitchen counter top.

No significant deficiencies or anomalies observed at the time of inspection.
